PLATE BONDED STRENGTHENED R.C. BEAMS WITH END AND INTERMEDIATE ANCHORS

M. Z. Jumaat and M. A. Alam
Dept. of Civil Engineering, University of Malaya, Kuala Lumpur, Malaysia.
Email: zamin@um.edu.my

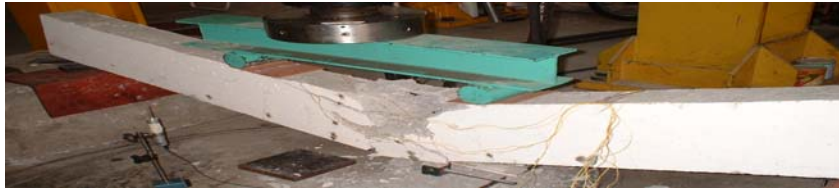
Plate 1. Failure mode of beam A1 (Control beam)

Plates 1, 2 and 3 show the failure modes for test beams of A1, B4 and C4 respectively. It was found from the test that beams A1 and B4 failed in flexure with a ductile failure mode whereas beam C4 failed with a concrete compression failure characteristic. It can be seen that all beams failed with a ductile mode of failure. Beam A1 failed in the natural manner expected of an under-reinforced concrete beam i.e. crack widening crushing of concrete. Beams B4 and C4 failed by concrete in the compression zone crushing but due to strengthening plate the concrete in the tensile zone remained intact.

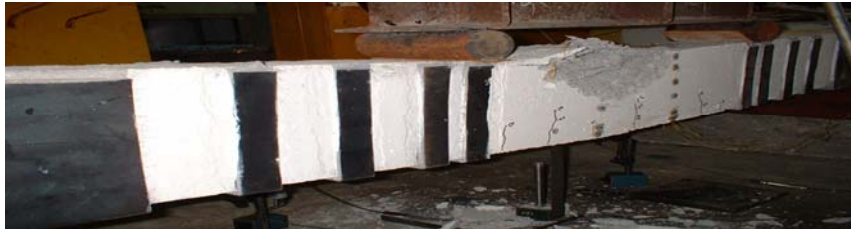
Plate 2. Failure mode of beam B4 (steel plate strengthened beam with L shape end and intermediate anchorages)

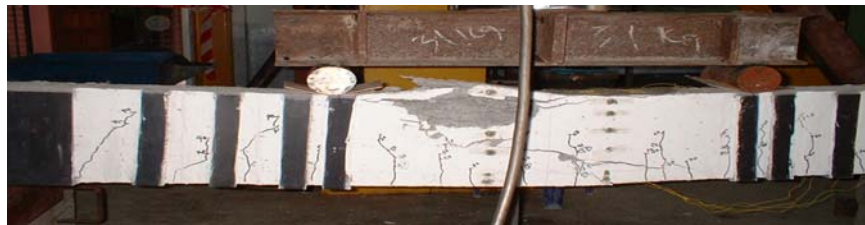
Plate 3. Failure mode of beam C4 (CFRP laminate strengthened beam with L shape end and intermediate anchorages)

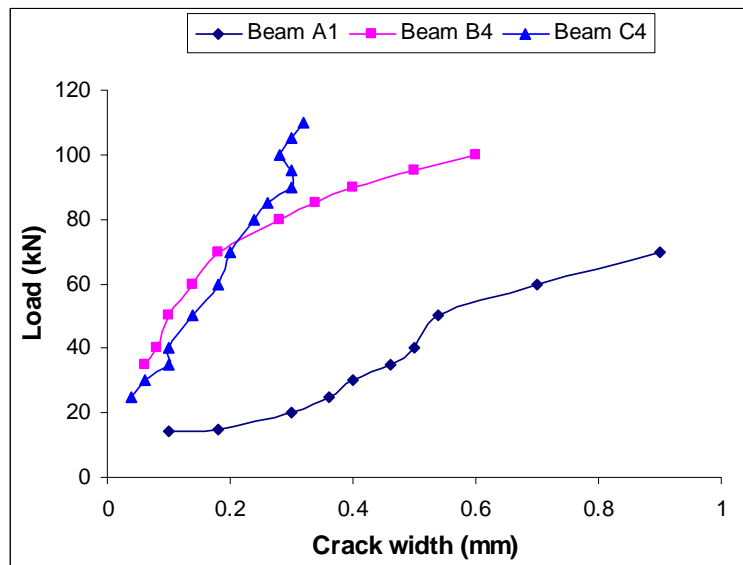
Fig 6 shows the load versus crack width curves for A1, B4 and C4. The strengthened beams B4 and C4 showed smaller crack widths compared to the control beam.

Figure 6: Behaviour of crack width of intermediate anchored strengthened beams
